(1) Fukushima Accident and Current Status of NPPs in Japan

Follow-up Training Course (FTC) Indonesia

On Reactor Engineering (RE)

***Nuclear Human Resource Development Center
Tokai, Japan Atomic Energy Agency (JAEA)***

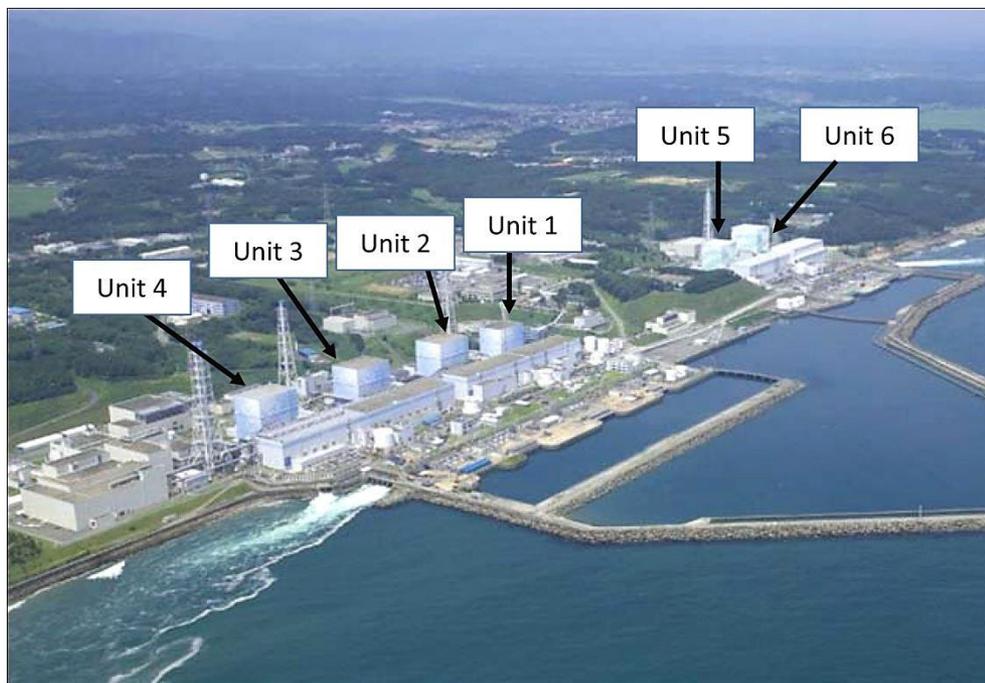
Specification of Each Unit of the Fukushima Daiichi NPS

(11 March 2011)

No.1	No.2	No.3	No.4	No.5	No.6
Output Power	460 MWe (1971~)	784 MWe (1974~)	784 MWe (1976~)	784 MWe (1978~)	784 MWe (1978~)	1,100 MWe (1979~)
Situation	Under Operation	Under Operation	Under Operation	Under Inspection	Under Inspection	Under Inspection
PCV* Type	BWR Mark- I					Mark- II

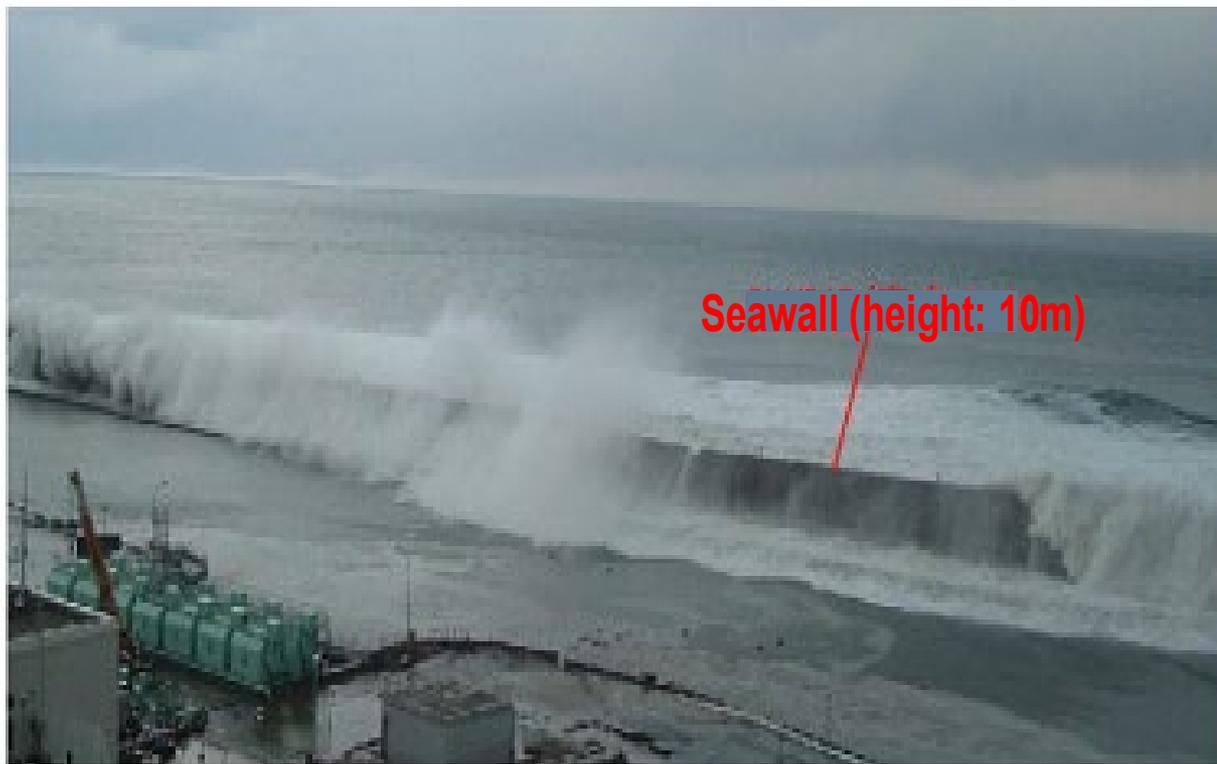
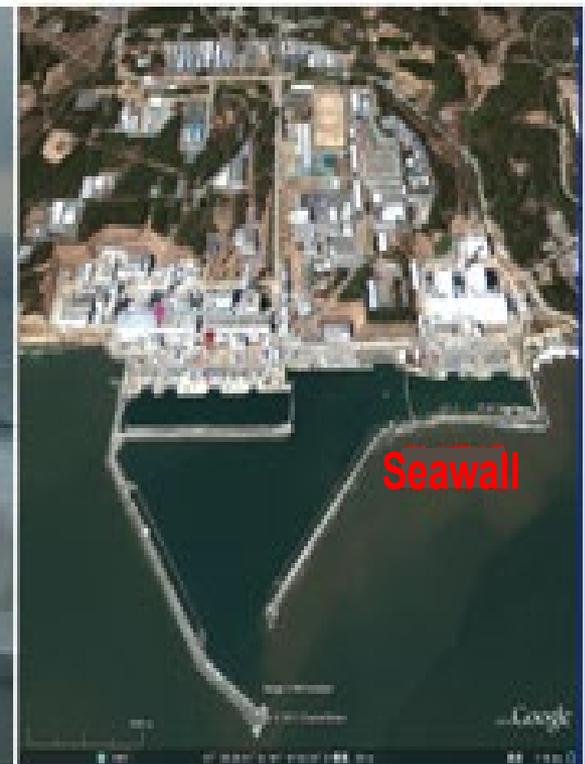
Scene of Tsunami Attacking the Site (1/3)

Tsunami of 15m height easily overflowed the **seawall of 10m** height of the Fukushima Daiichi NPS 1hr after the big earthquake.

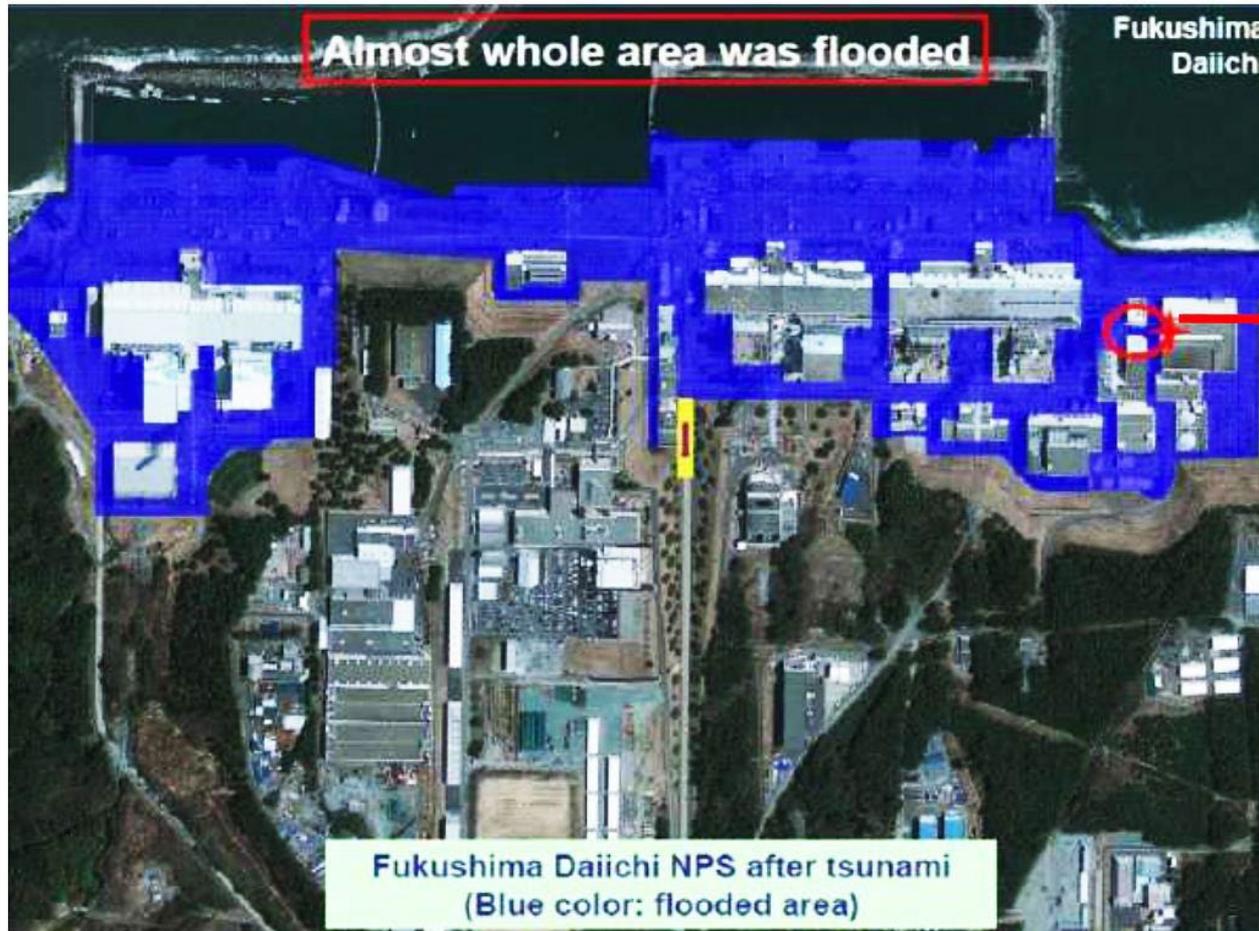
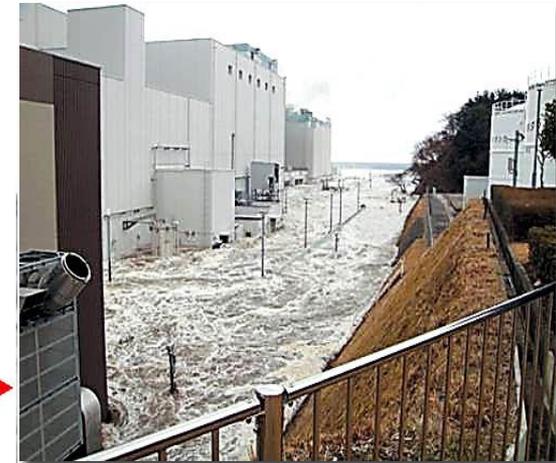
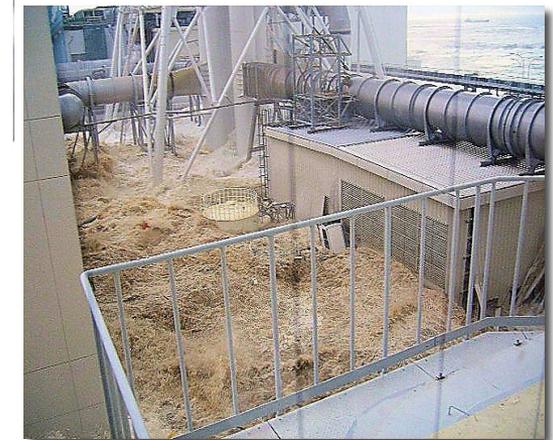
Scene of Tsunami Attacking the Site (2/3)

Fukushima Daiichi NPS was flooded about 5m due to the Tsunami of 15m height coming 1hr later of the earthquake. (for 5 min.)

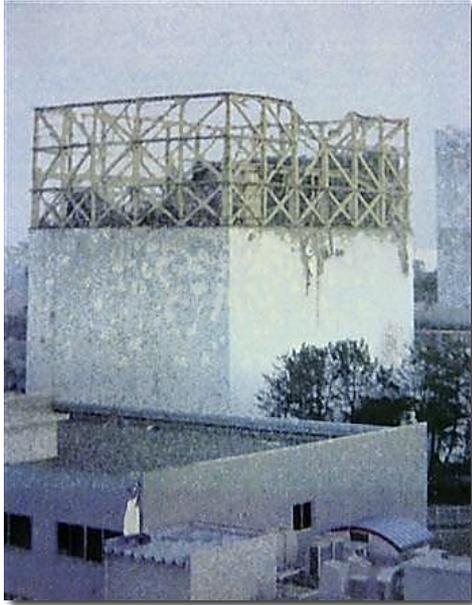
<Unit No.1>

Sky Photographs of Unit No.1-No.4 After the Accident

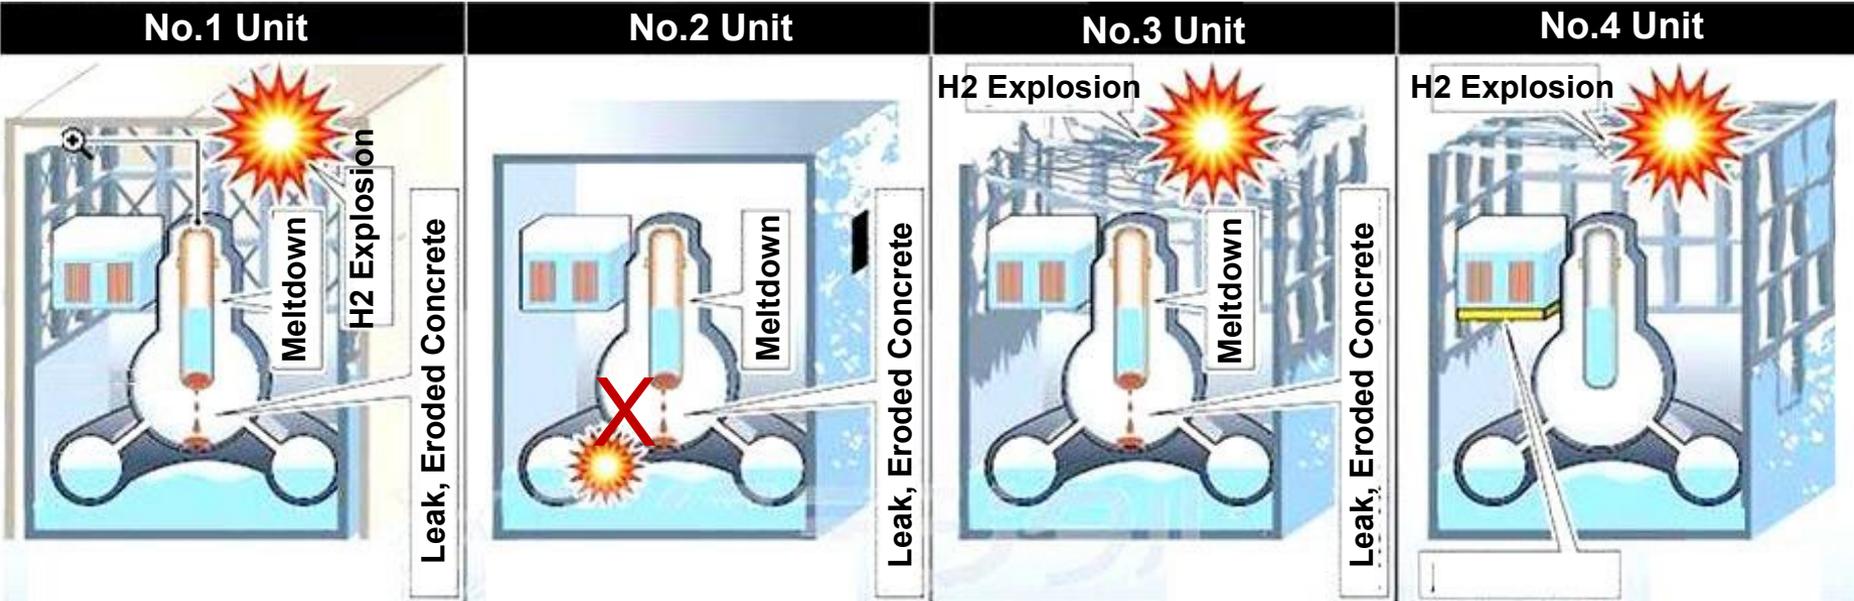
Summarization of Each Unit's Damage (Unit No.1-No.4)

- Fuel Meltdown**
 - ☞ Unit-1, Unit-2 and Unit-3
- Hydrogen Explosion**
 - ☞ Unit-1, Unit-3 and Unit-4
- Broken of PCV**
 - ☞ Unit-2

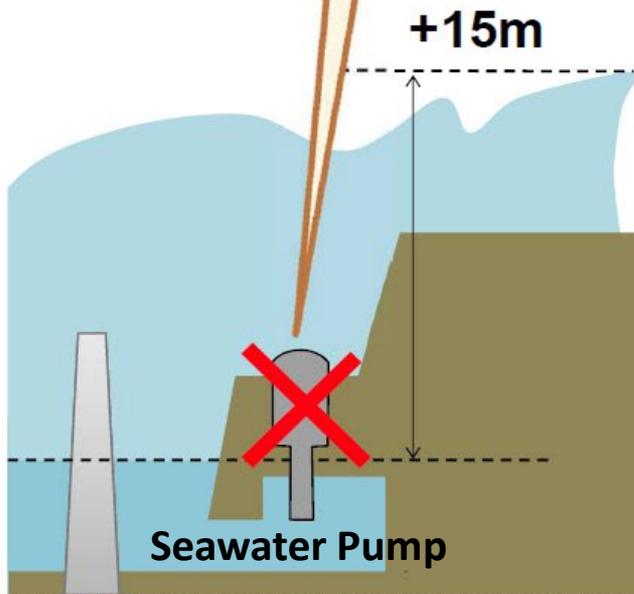
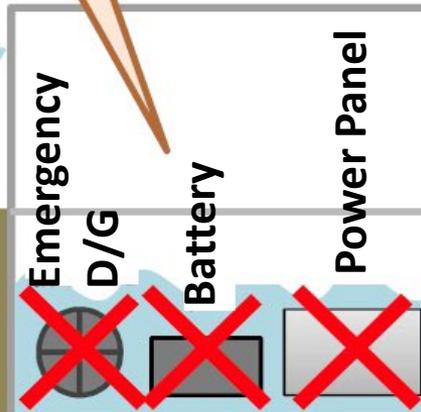
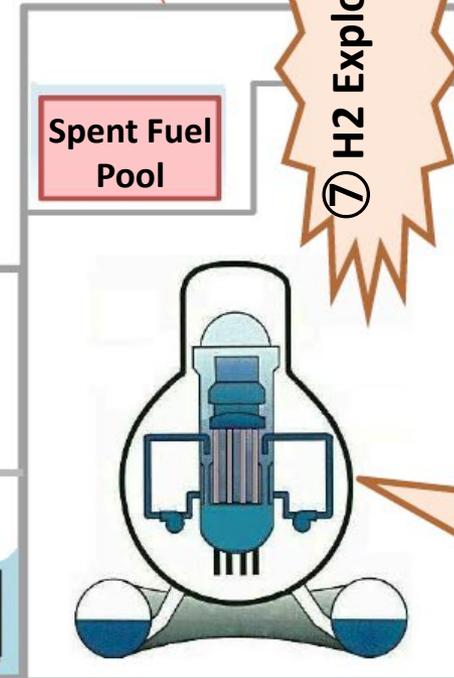
Loss of All Safety Functions by Loss of Total Power by Flooding due to Tsunami

① Station Blackout by Big Earthquake

② Loss of Total Powers (AC & DC) by Flooding due to Tsunami

Progressing Severe Accident by Loss of Final Heatsink

③ Stop Cooling
↓
④ Fuel Meltdown
↓
⑤ Generation of Hydrogen
↓
⑥ Leak of Hydrogen (Damage of CV)

- ❑ Important Equipment, such as Emergency Diesel Generators, Distribution Boards, Batteries, were flooded. ✗
- ❑ Total Power Loss (External Power + Emergency Diesel Generator + Battery) ✗
- ❑ Final Heat-sink lost caused by Seawater Pumps (Loss of Cooling Function) ✗

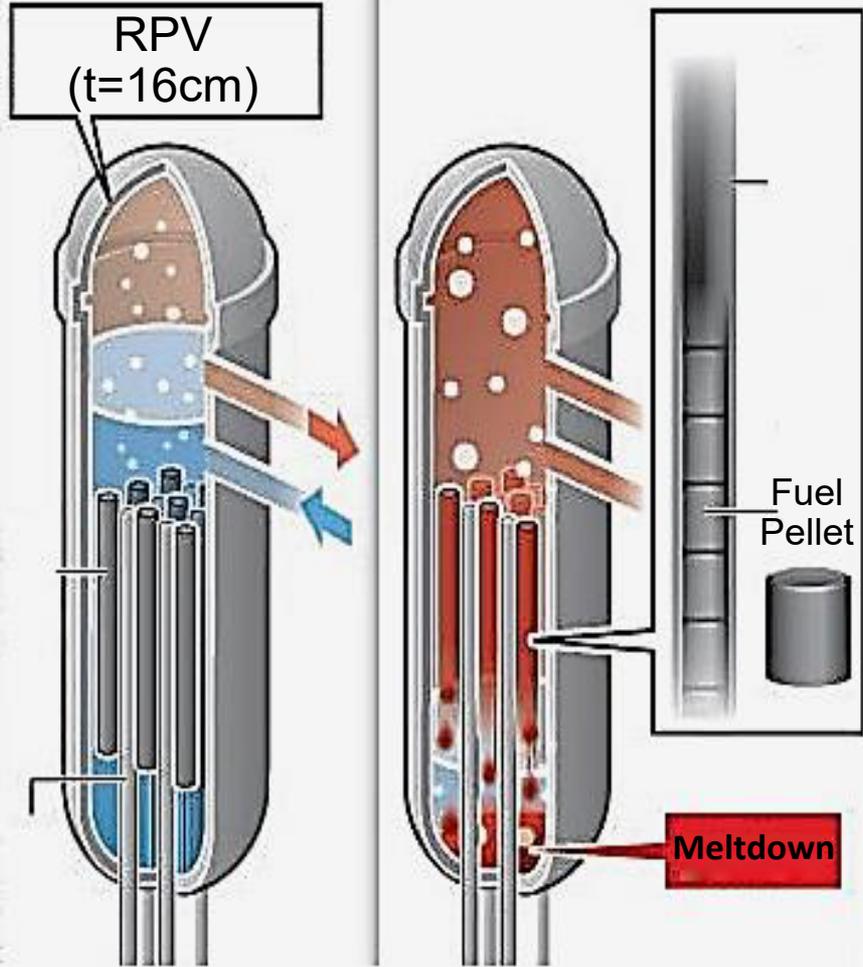
Fuel Meltdown due to LOCA (Loss of Coolant Accident)

A Core should be **cooled** even after Reactor Shutdown because of that **Decay Heat** remained in a core.

Normal State

LOCA State

Fuel Meltdown Time after Tsunami Flooding	
Unit-1	After ~15h
Unit-2	After ~1011h
Unit-3	After ~60h

Fuel Pellet Temperature (U-235)	
Under Normal Operation	~1,740°C
Melting Points under LOCA	
Fuel Pellet (U-235)	~2,400-2,860°C
Fuel Cladding (Zircaloy)	~1,850°C

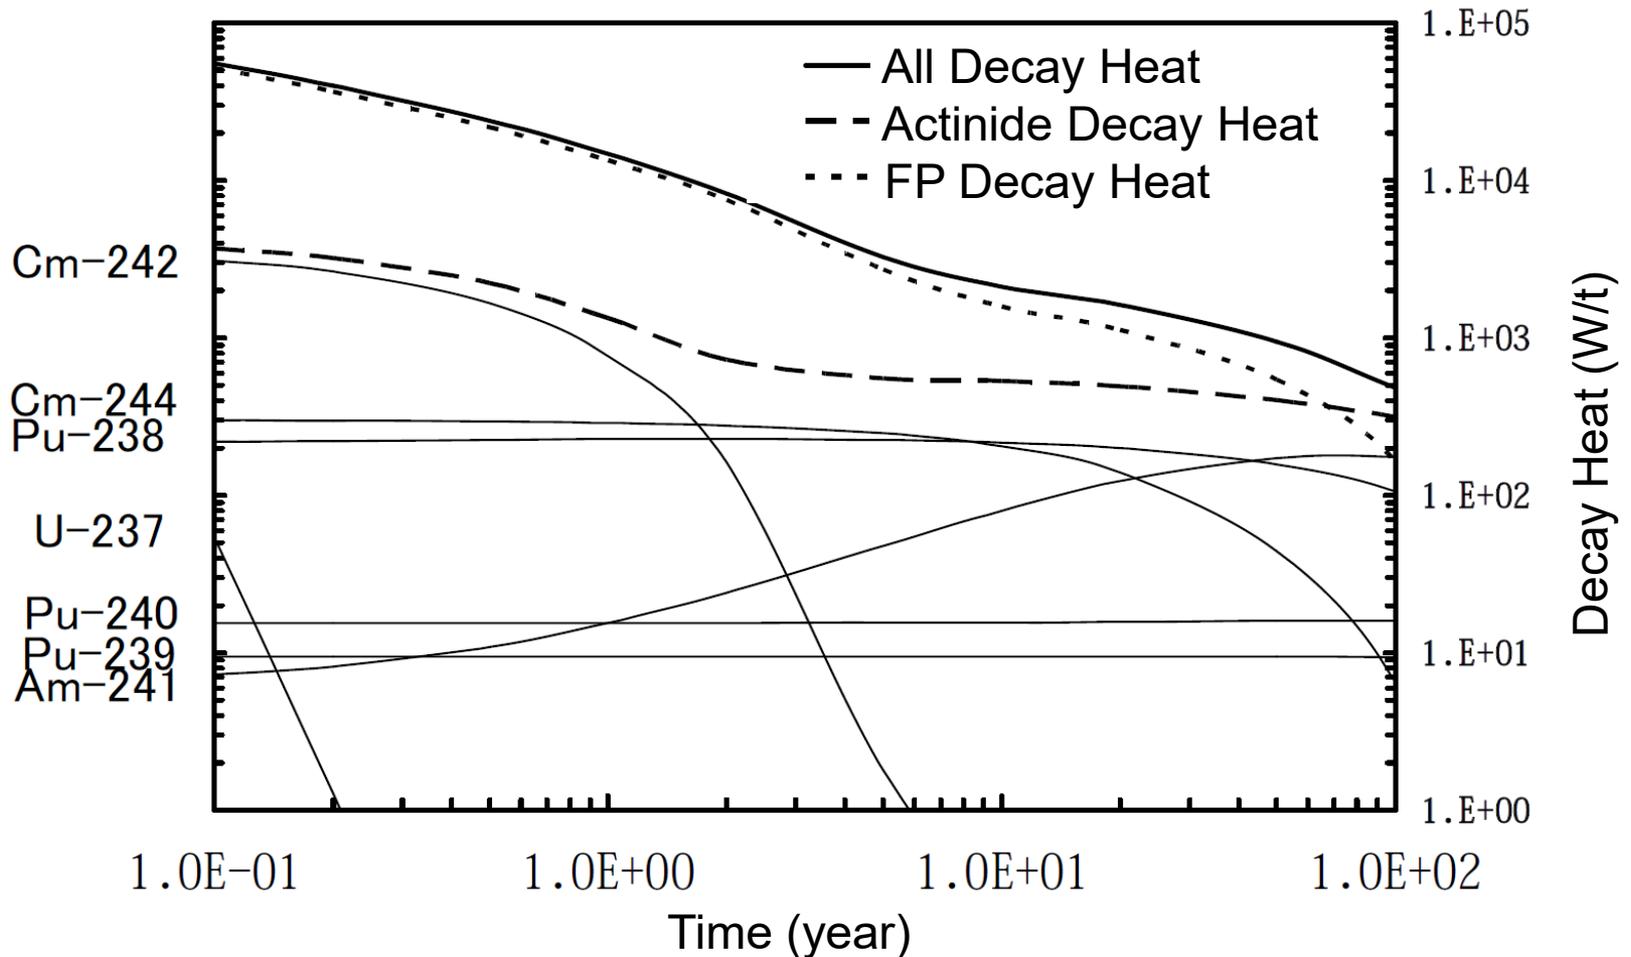
Decay Heat Curve of LWR (Uranium Fuel)

- ◆ Decay heat from Fission Products (FP) is dominant within several years.

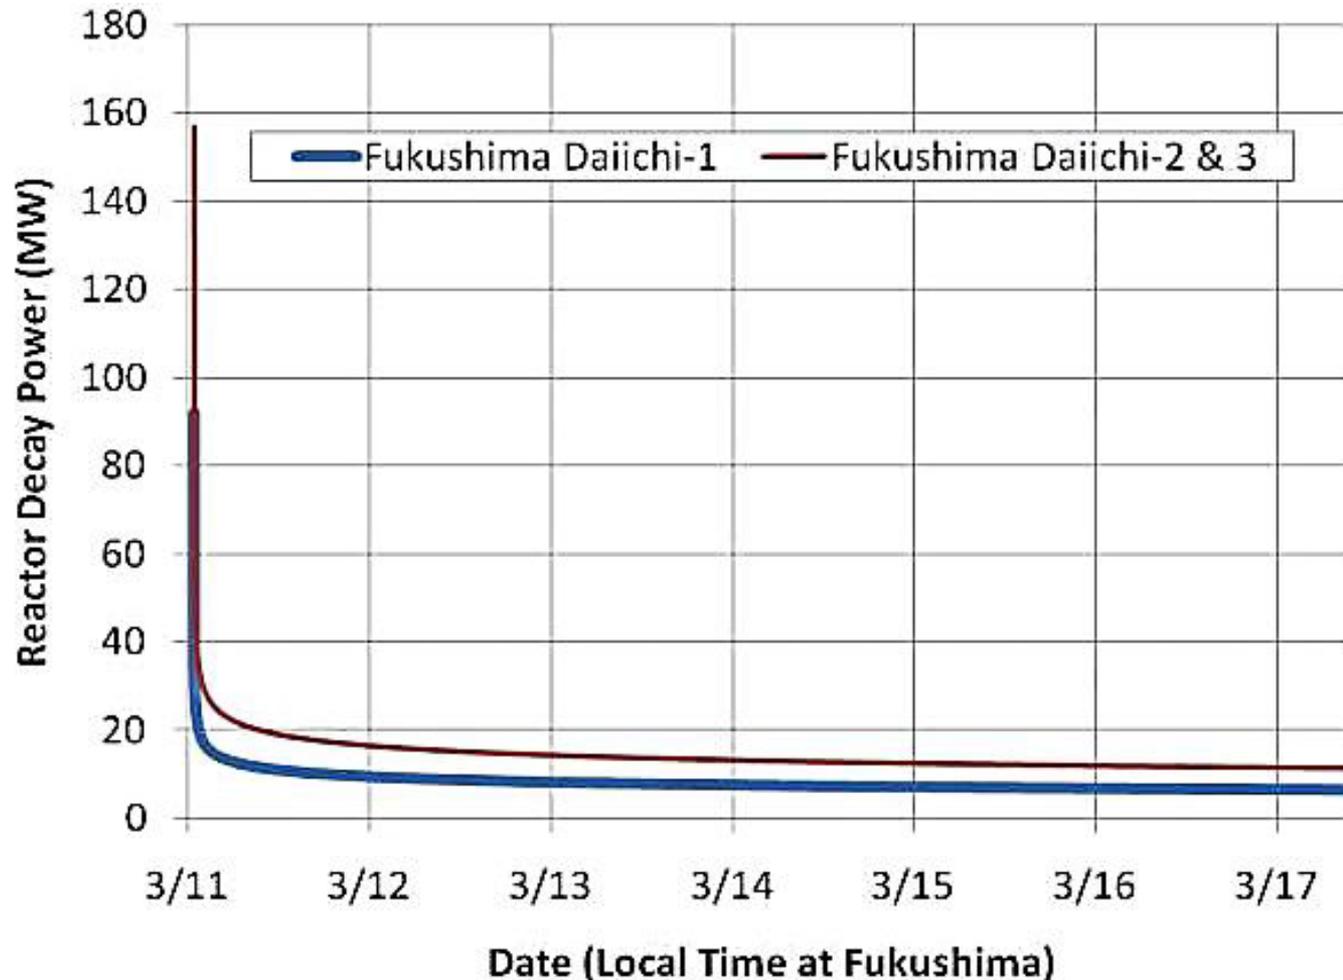
Decay Heat Curve of Fukushima Daiichi NPS (Unit No.1-No.3)

- ◆ The decay heat right after shutdown of nearly 7% of the rated power decreases very quickly, for example, it drops off to less than 1% after around 5 hours.
- ◆ However, it remains approximately 0.2% even one year later.

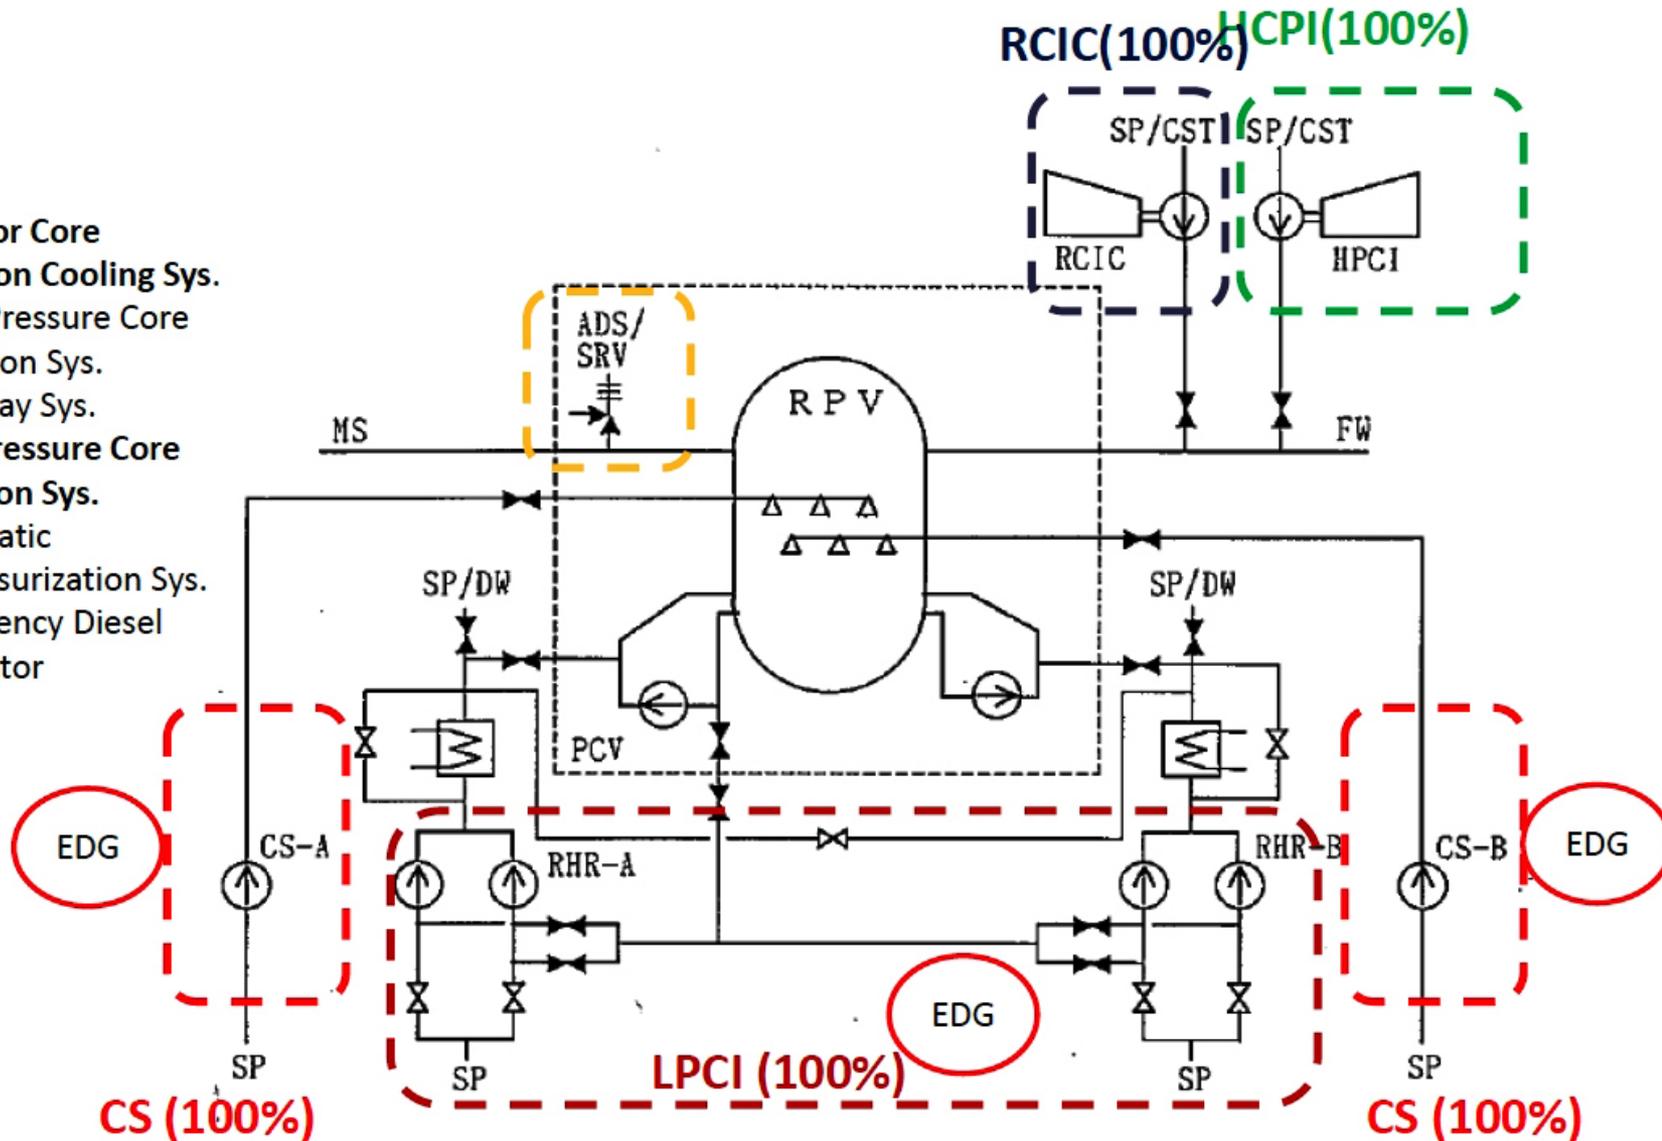
ECCS System of Fukushima Daiichi NPS (Unit No.2-4)

- RCIC: Reactor Core Isolation Cooling Sys.
- HPCI: High Pressure Core Injection Sys.
- CS: Core Spray Sys.
- LPCI: Low Pressure Core Injection Sys.
- ADS: Automatic Depressurization Sys.
- EDG: Emergency Diesel Generator

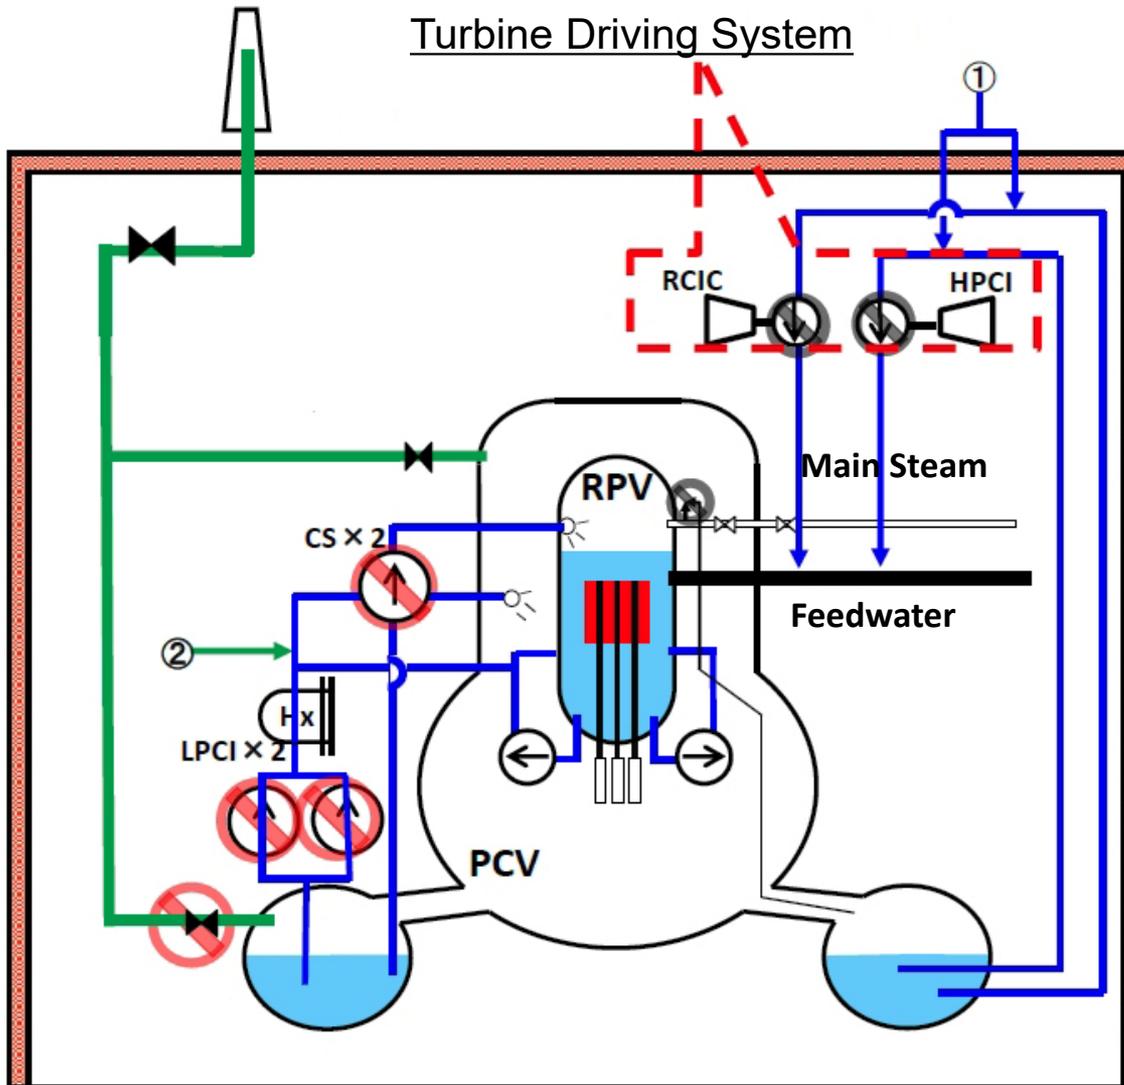
Malfunction of ECCS System of Fukushima Daiichi NPS (Unit No.3)

: Loss of DC Power
-

: Loss of AC Power
-

: Loss of Water Source

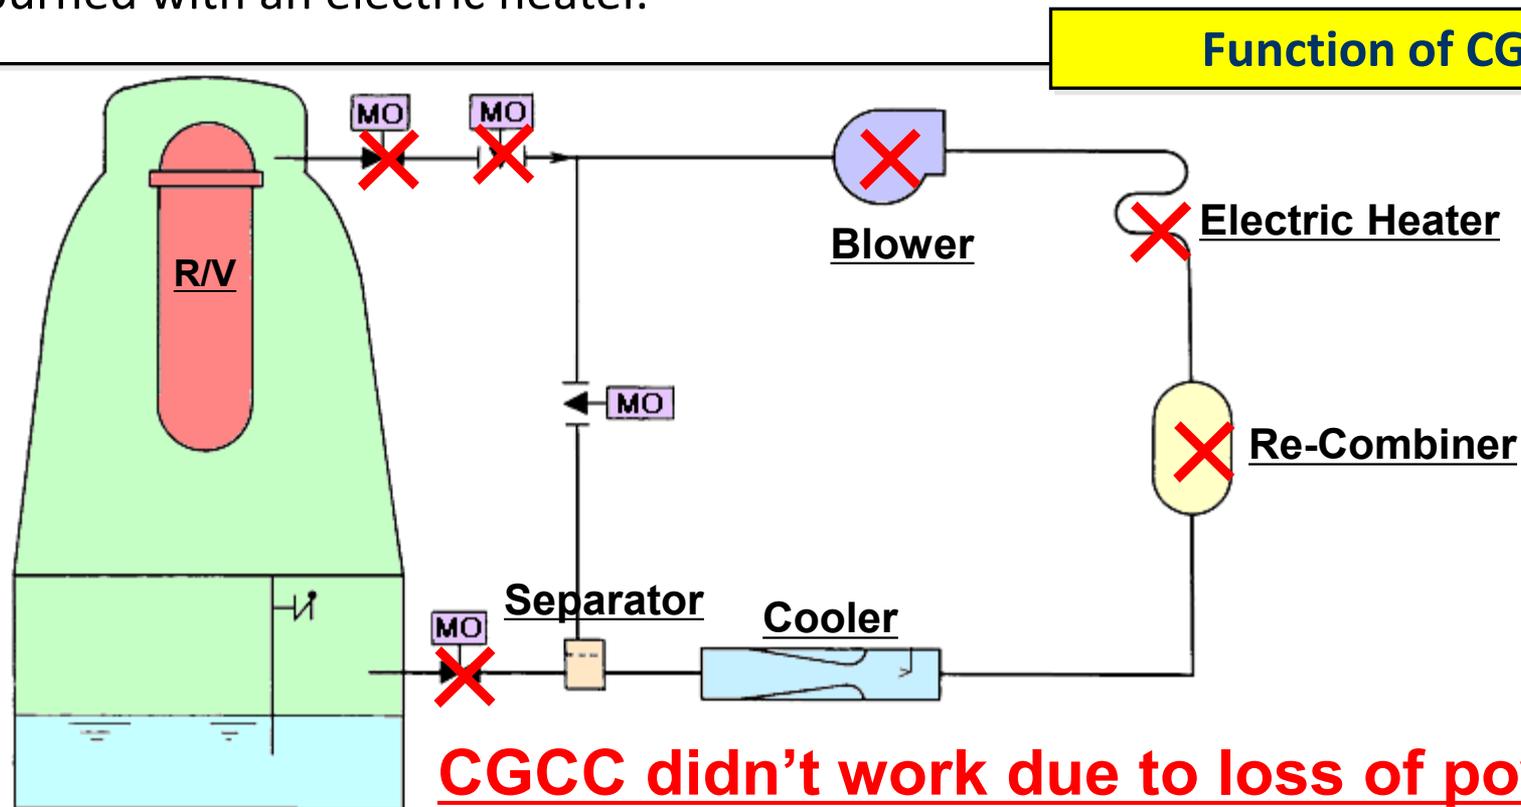
Malfunction of Combustible Gas Concentration Control System (CGCC) under the Accident

- ◆ The **Concentration of Hydrogen** produced in LOCA has to be controlled **less than 4%** which is the **Explosion Limit Value**.
- ◆ By CGCC, Hydrogen is re-united with oxygen at a Re-combiner and then it is burned with an electric heater.

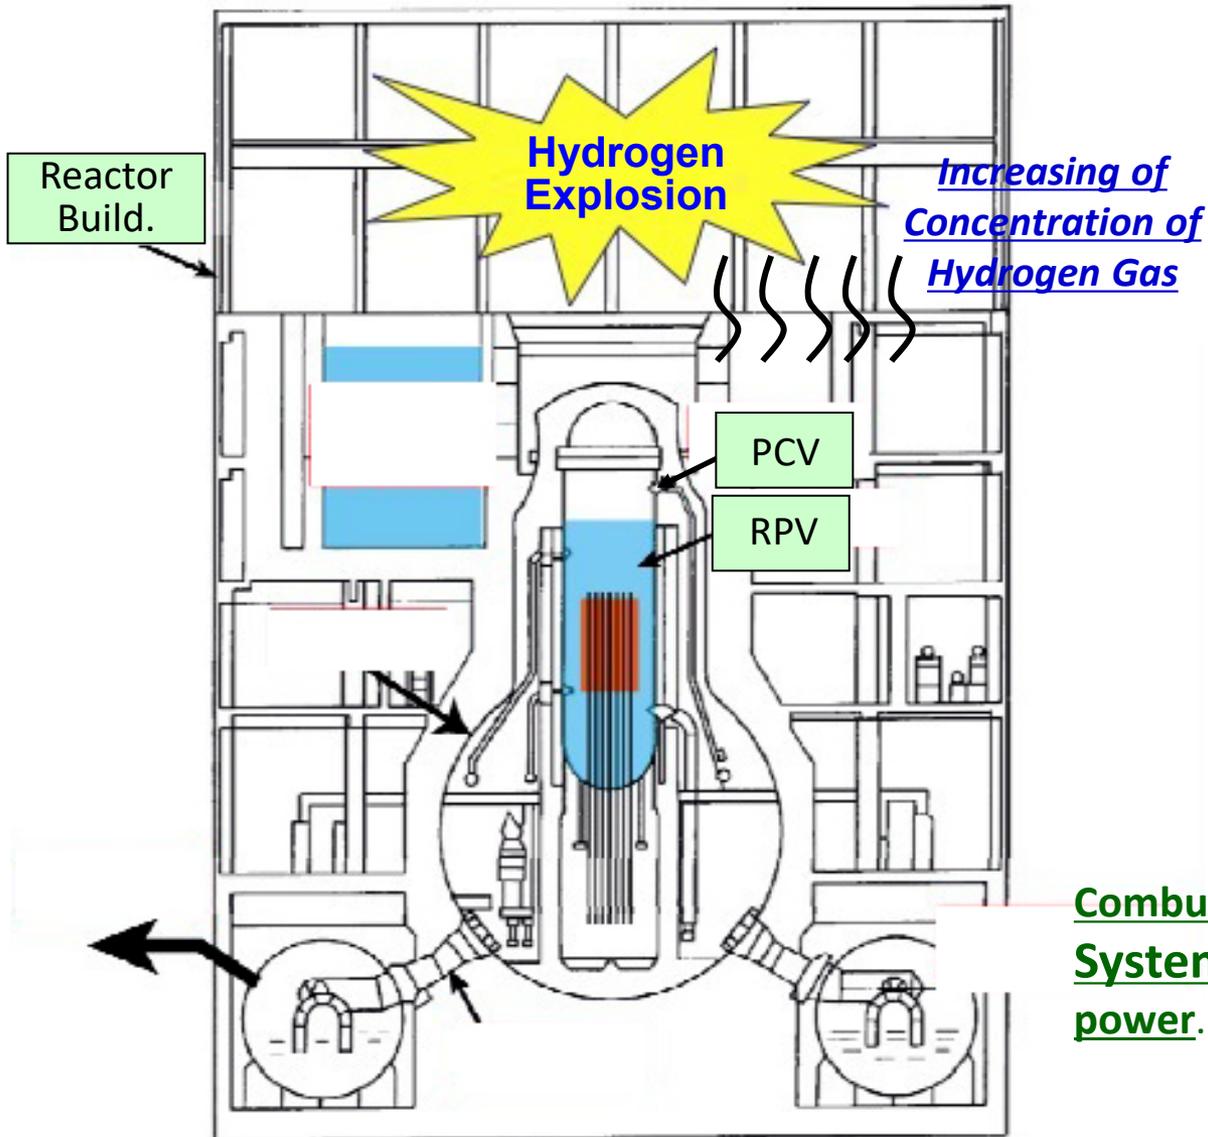
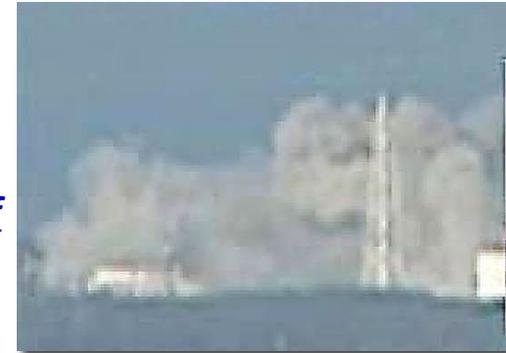
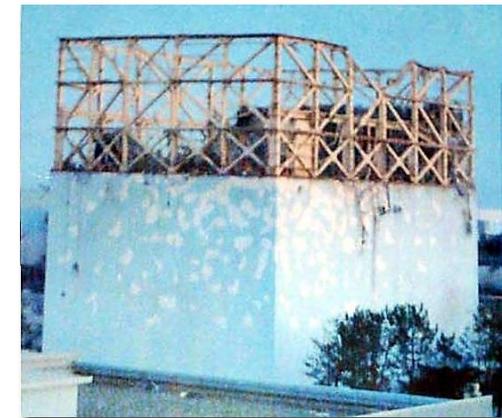
Hydrogen Explosion at Unit-1

Hydrogen Gas Explosion occurred at Reactor Operating Floor (Outside of PCV)

Combustible Gas Concentration Control System didn't work due to loss of power.

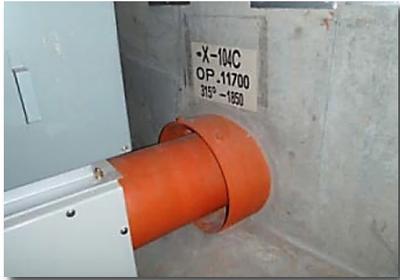
<Cable Penetration>

Why did Hydrogen leak from PCV?

Silicone Rubber, Epoxy Resin

Leak arose at some parts of PCV due to Degradation of Seal Materials of PCV Penetration, which was caused by Overpressure and Heat Radiation from RPV.

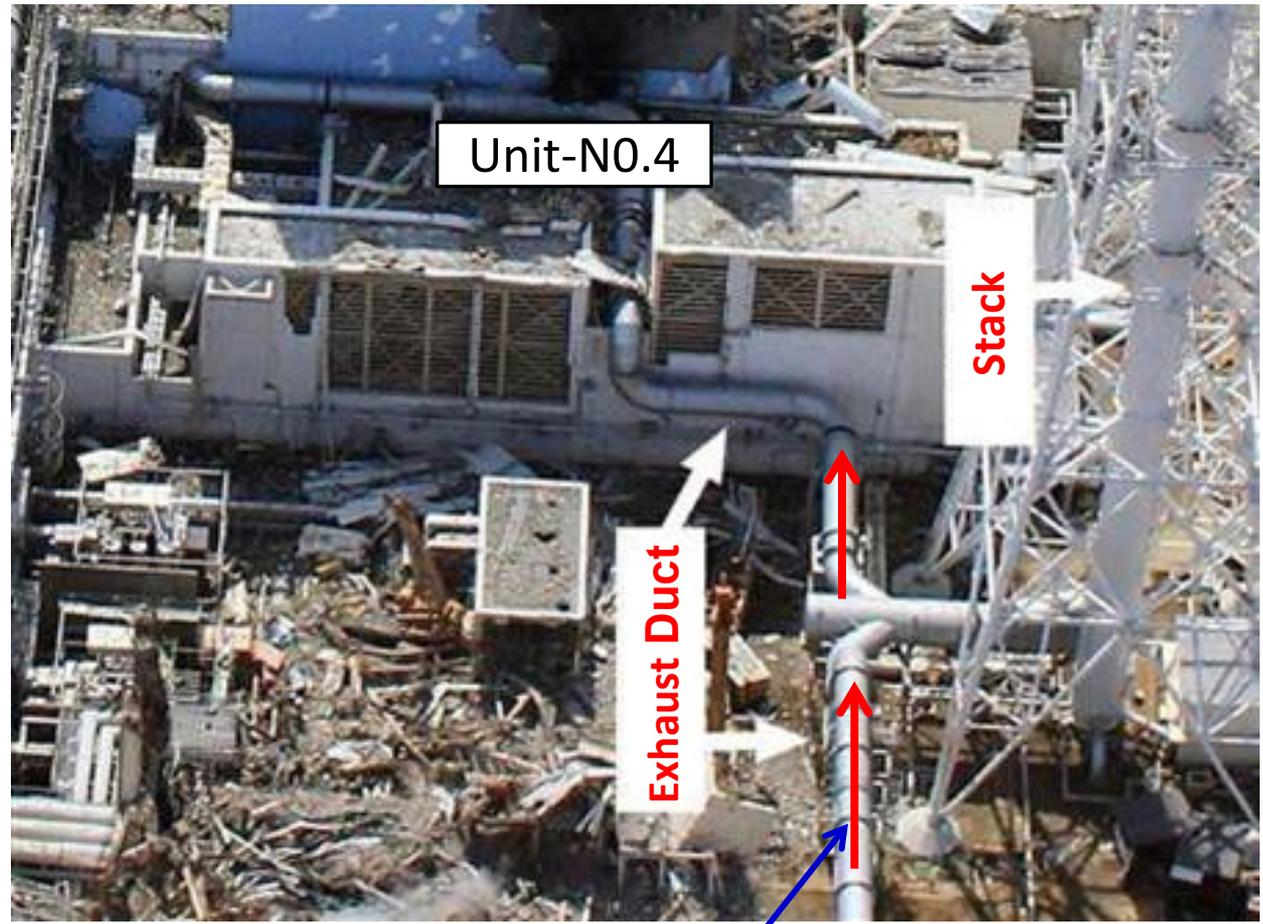
Exhaust Line from No.3 Unit

An Exhaust Stack Sharing by Unit No.3 and No.4

- ◆ As shown the right picture, a stack is shared by unit No.3 and No.4.
- ◆ When venting operation at unit No.3 have been carried out, it seemed that **hydrogen gas leaked into unit No.4 through a exhaust duct connecting with unit No.3's duct** due to a valve was opened by loss of driving power.

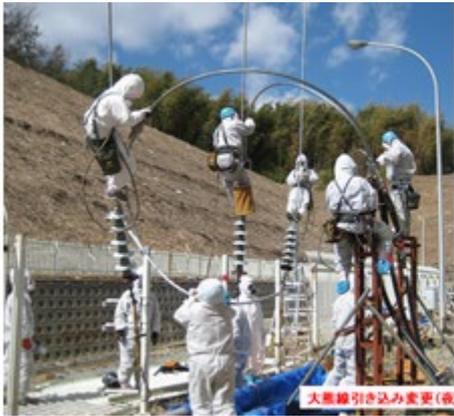
Restoration of External Power, installing portable power distribution board on March 18~19

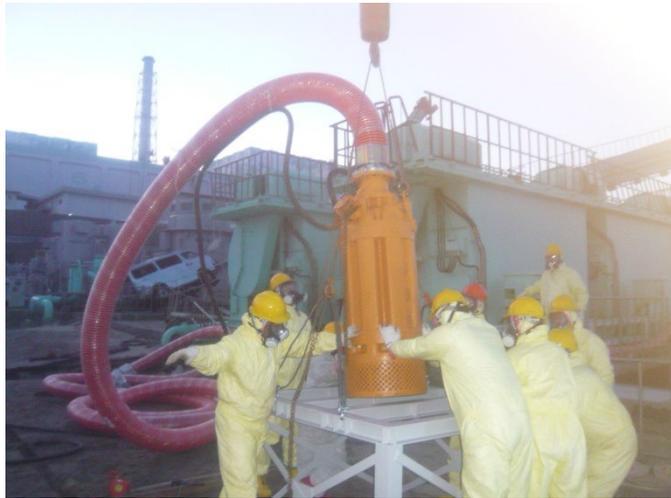
Installing submersible pump for Unit 5 & 6

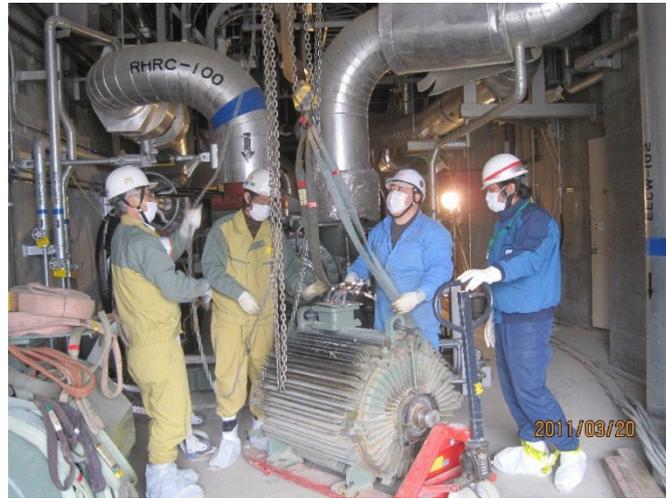
Restoring seawater pump in Fukushima Daini

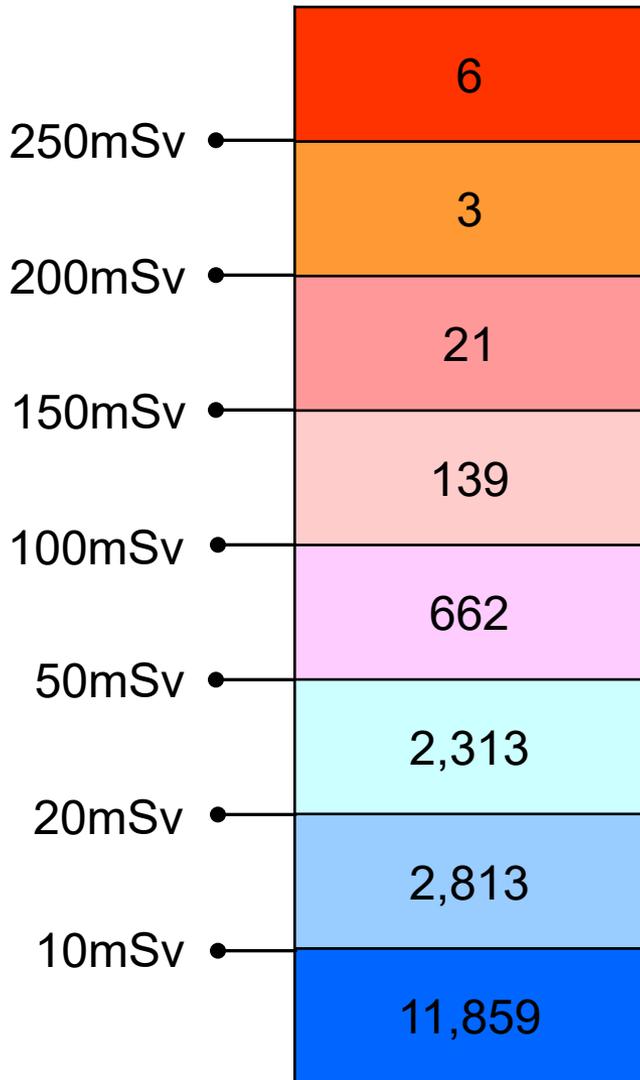
Total Exposure Dose of Fukushima Daiichi NPS Radiation Workers in 2011

Allowable Dose Limit in Emergency Case (250mSv*)

Allowable Dose Limit in Normal Case (100mSv)

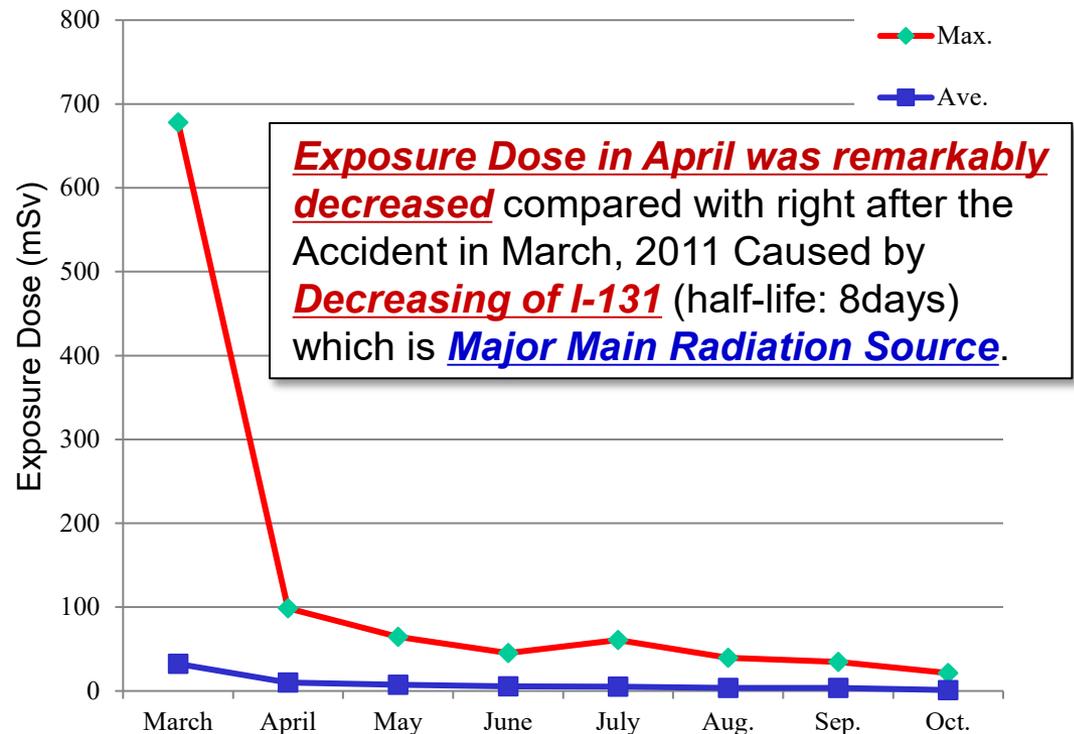
Total Exposure Dose of Fukushima Daiichi NPS Radiation Workers in 2011 (cont.)

March	April	May	June	July	Aug.	Sep.	Oct.
Max. (mSv)	678.1	98.6	64.5	45.3	50.8	39.4	34.7	21.4
Ave. (mSv)	32.3	10.1	7.4	5.5	5.3	3.8	3.6	1.1

◆ Right after the Accident in March, Two workers were exposed over 650mSv exceeded greatly the Permissible Dose of 250mSv for Emergency Work (Provisional Value).

◆ From May, the average dose transitions under 10mSv.

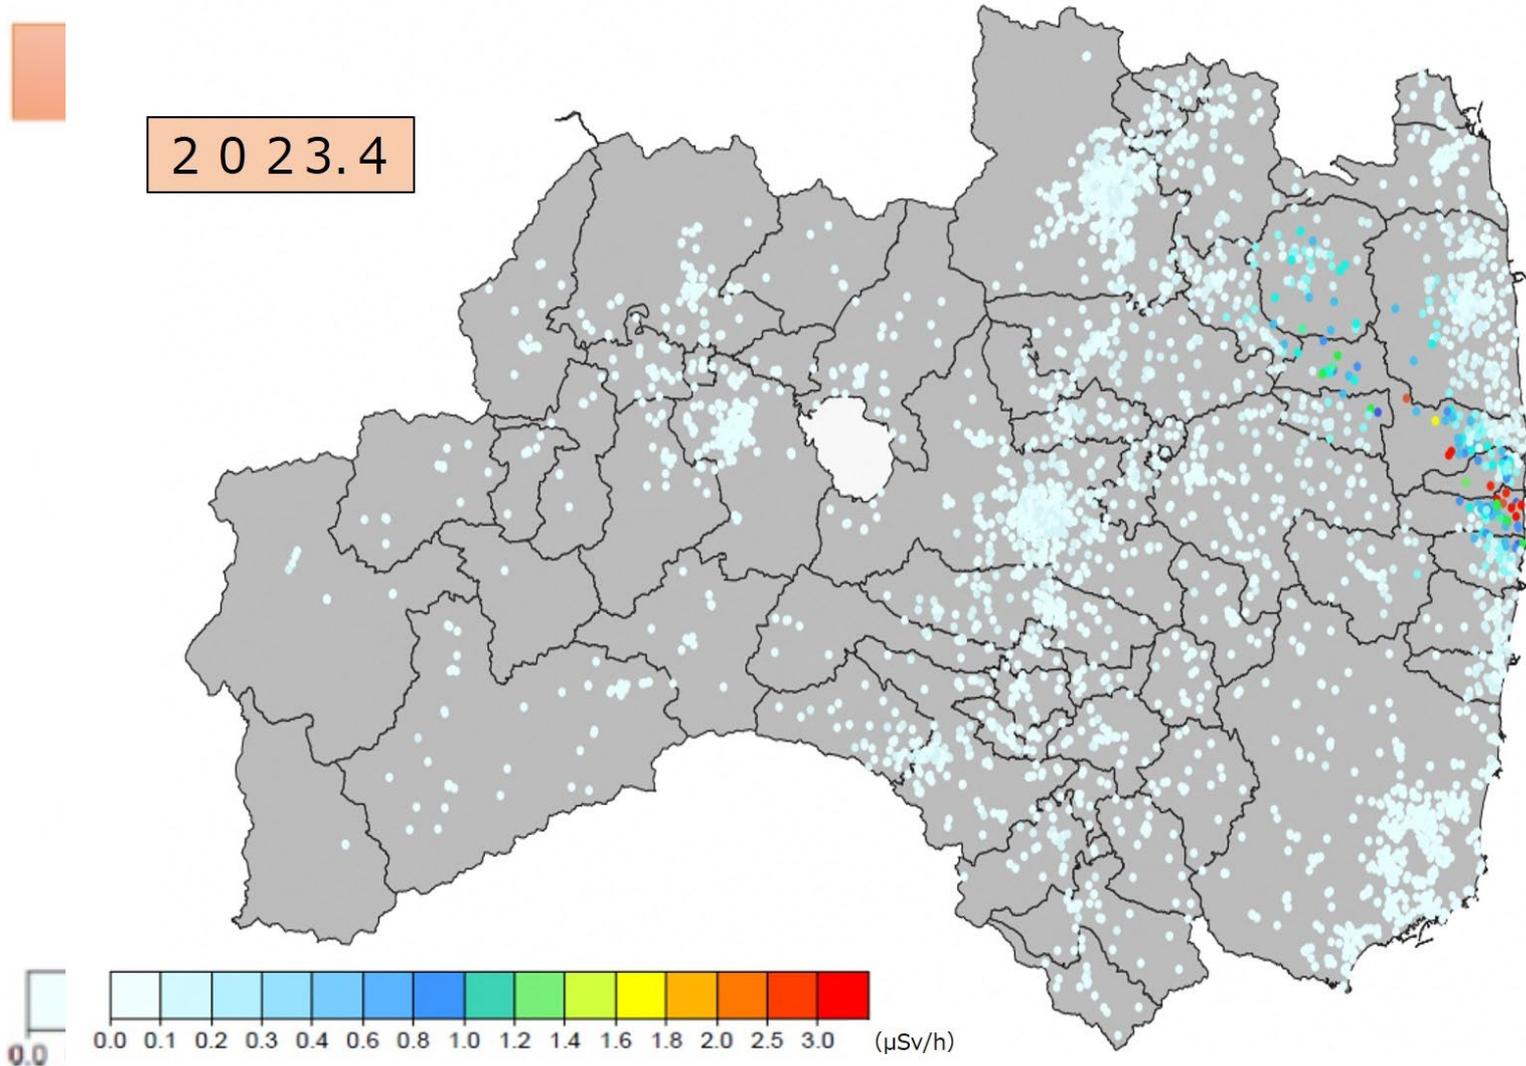
Fukushima Prefecture Radioactivity measurement map

$\mu\text{Sv/h}$
