(1) Fukushima Accident and Current Status of NPPs in Japan

Follow-up Training Course (FTC) Indonesia

On Reactor Engineering (RE)

***Nuclear Human Resource Development Center
Tokai, Japan Atomic Energy Agency (JAEA)***

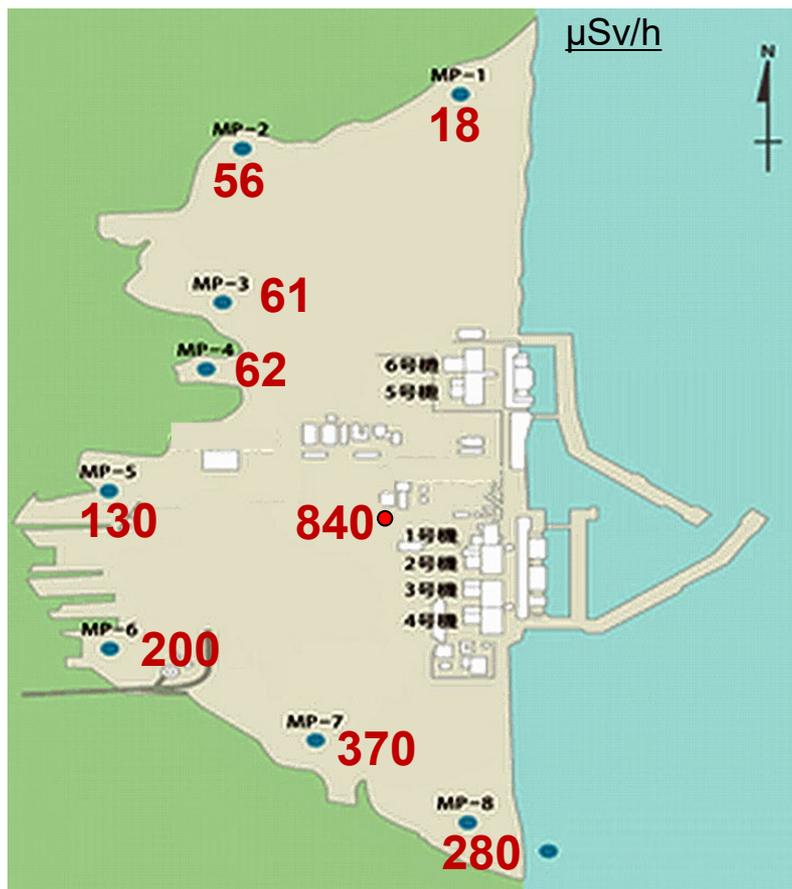
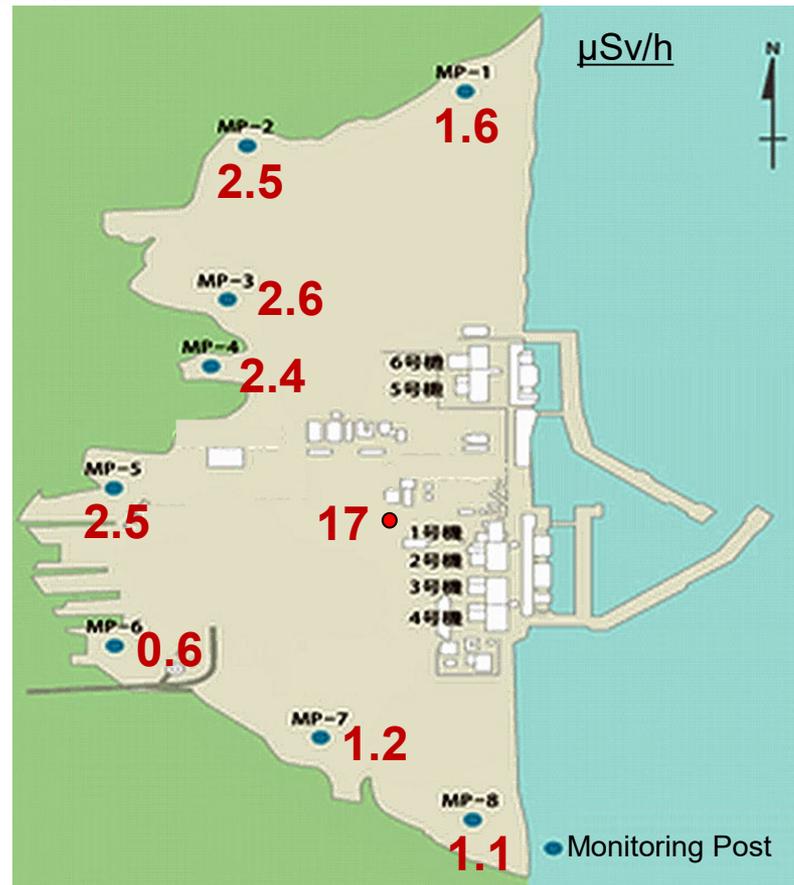
Present Ambient Dose Rate at the Fukushima NPS-1

<April 2nd, 2011> *Starting Operation of Monitoring System

<As of June 1st, 2016>

(Max. Air Dose Rate)

370 $\mu\text{Sv/h}$	$370 \times (8\text{h} + 16\text{hx}0.4) \times 365 =$ 1,944.7mSv/y
840 $\mu\text{Sv/h}$	$840 \times (8\text{h} + 16\text{hx}0.4) \times 365 =$ 4,415.0mSv/y

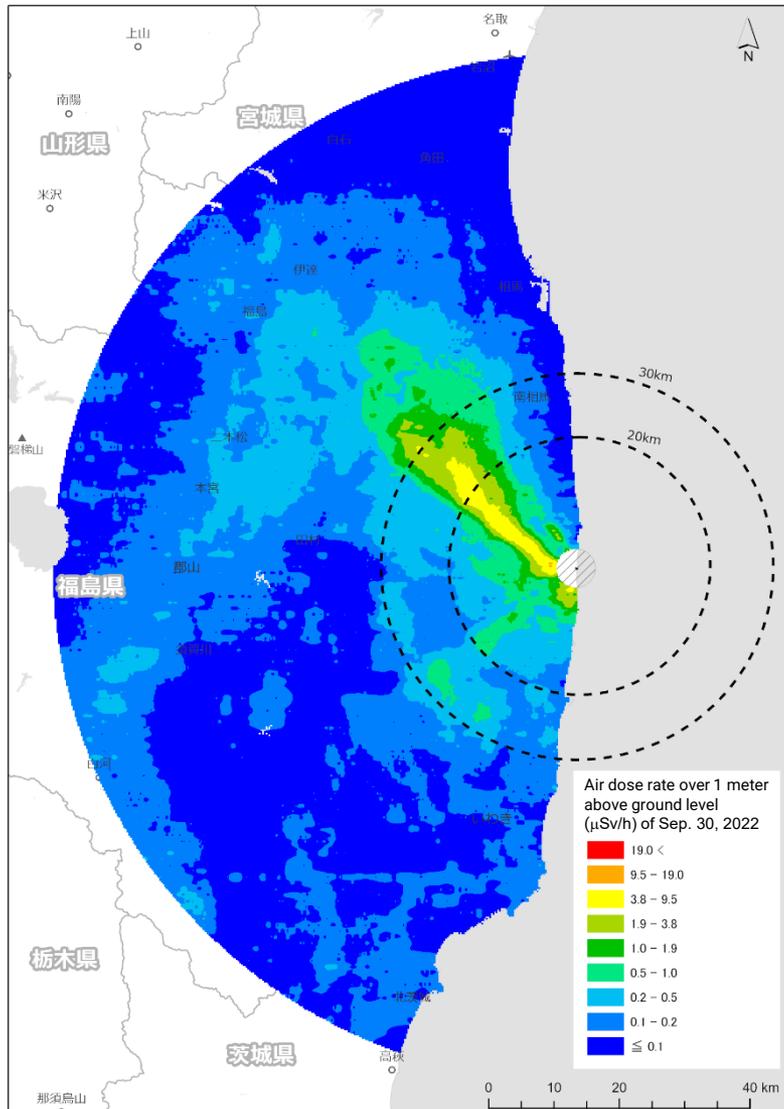
Manned heli survey

Latest radiation monitoring data (2022)

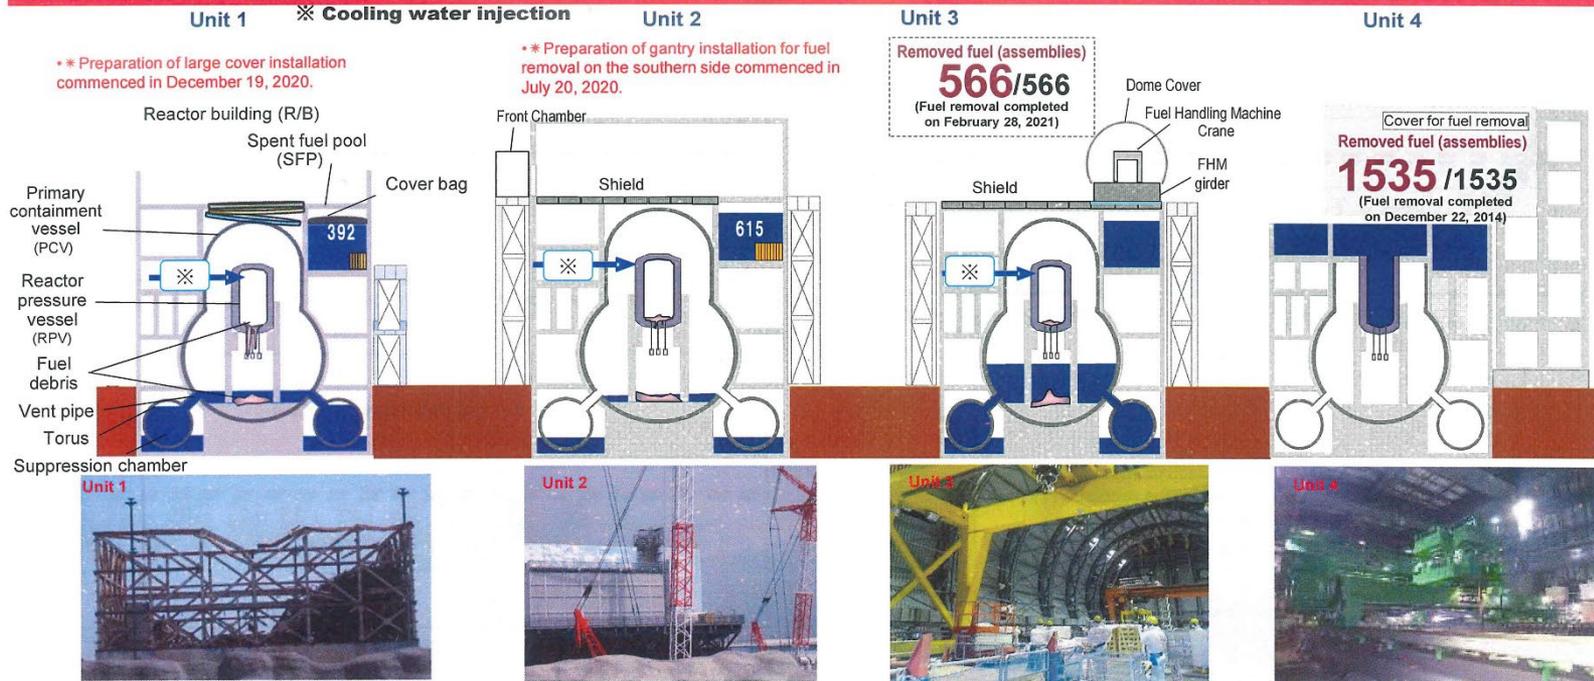
(1) State of Units 1-4

All reactors are in cold shutdown condition

Values as of 11:00 on November 8 2023

RPV bottom temp.	PCV internal temp.	Fuel pool temp.	Water injection to the reactor
Unit 1	~26°C	~25°C	~27°C	3.7 m ³ / h
Unit 2	~35°C	~35°C	~27°C	1.5 m ³ / h
Unit 3	~29°C	~28°C	Not monitored as all fuel removal is complete.	3.8 m ³ / h

Plant parameters, including RPV and PCV temperatures, are monitored continuously 24 hours a day.

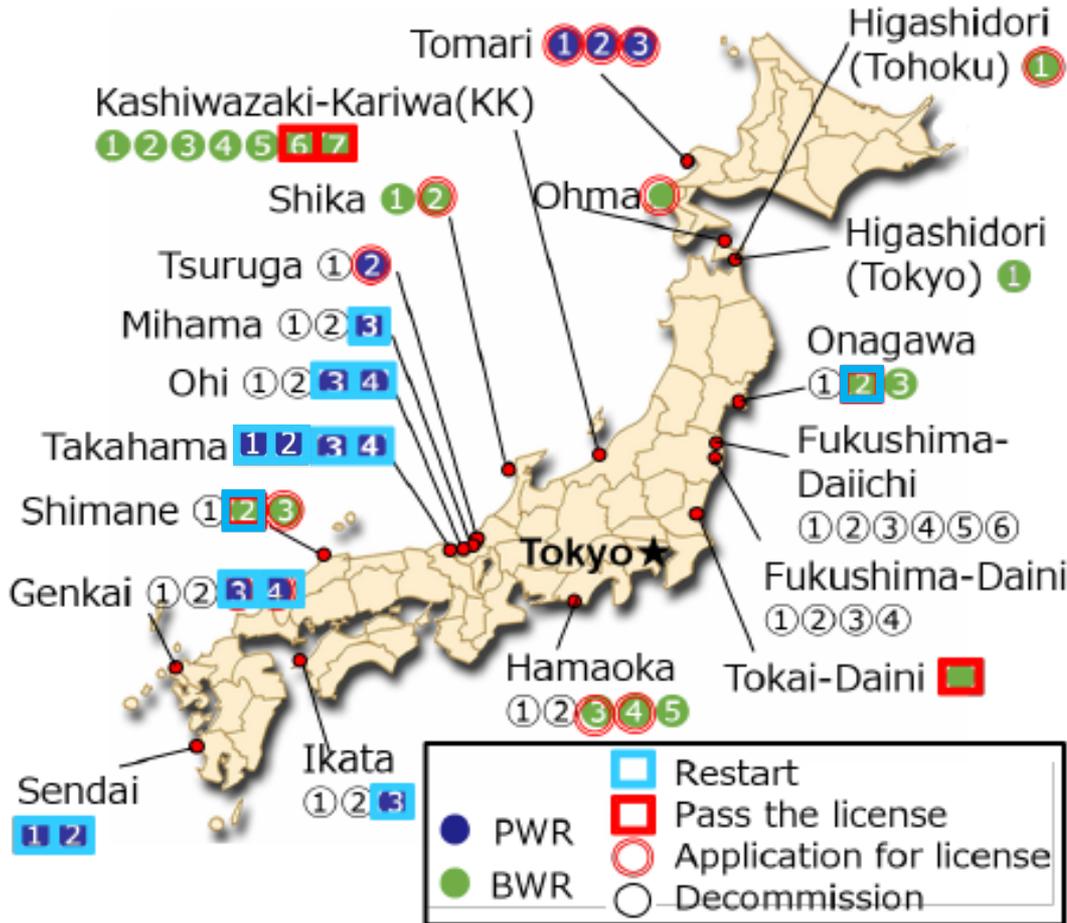
Status of Nuclear Power Stations in Japan

Status	PWR (●)	BWR (●)	Total
Restart (□)	12	2	14
Pass (□)	0	3	3
Application (○)	4	6	10
Preparation	0	9	9
Total	16	20	36

Status	PWR	BWR	Total
Decommission (○)	8	15	23

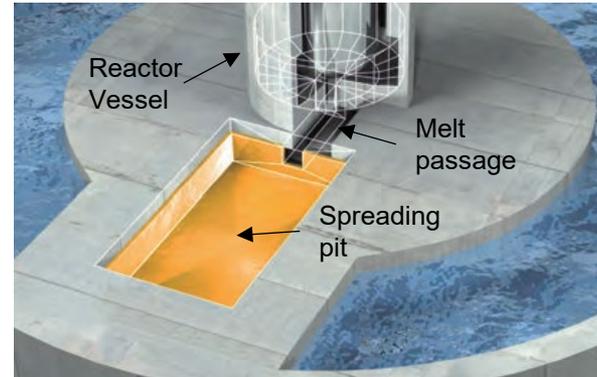
Materials release prevention system

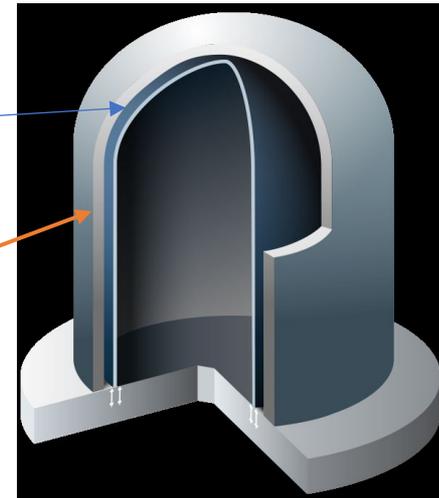
Containment Vessel Damage Protection Measures

Inner containment vessel
(High tensile steel sheet)

external shielding wall
(thickness about twice)

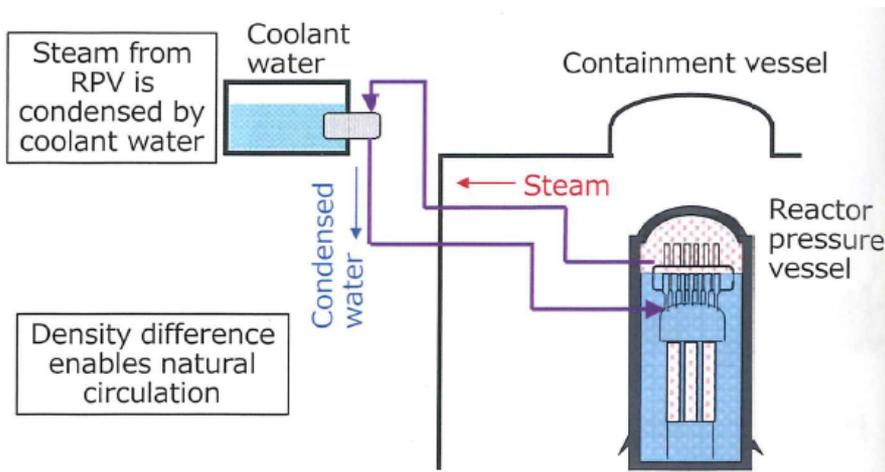
Passive Reactor Cooling System (PRCS)

- Remove decay heat by natural circulation at BDBE*
- No operator actions required with automatic start
- Capacity to operate for 24 hours

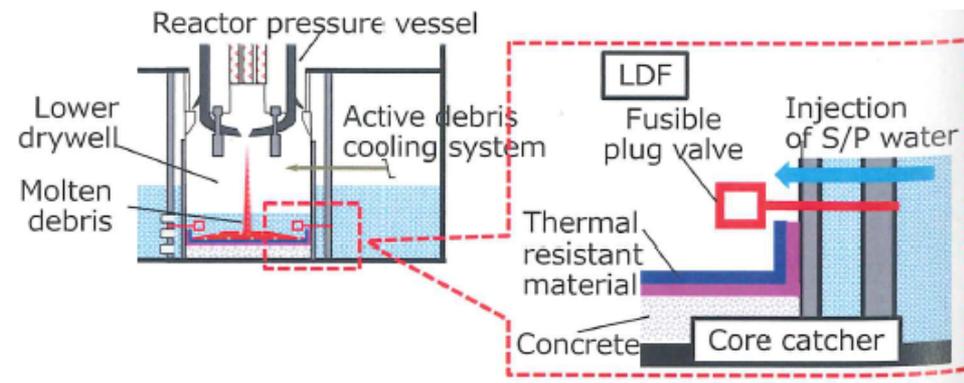
Core catcher + Lower Drywell Flooder (LDF)

- Core catcher placed at ABWR lower drywell.
- LDF: Fusible plug valve automatically injects the water of suppression pool (S/P) without operator actions. (S/P is large enough to enable debris cooling for 3 days)
